Lasers in Manufacturing Conference 2023

Defects formation in ultrafast laser machined glass

Abstract

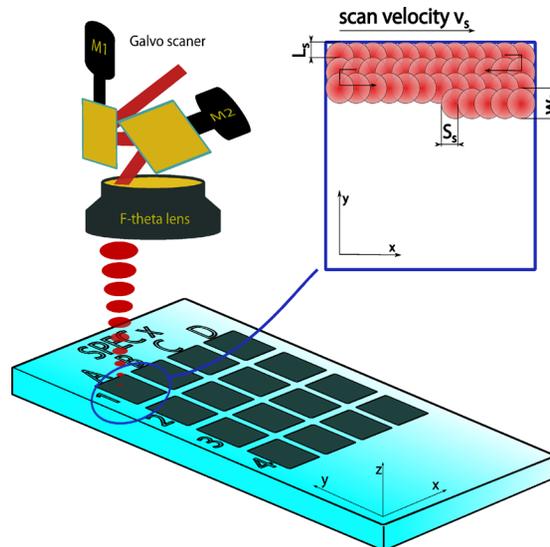
Fig. 1. Schematic of specimen processing

On each fused silica specimen, an array (Fig. 1) of rectangular cavities of dimensions 2.8 mm \times 2.8 mm was machined using different scanning parameters and fluence. Höhm et al., 2012 and Nieto et al., 2015, reported threshold fluence of fused silica as $F_{th} = 3.45 \text{ J}\cdot\text{cm}^{-2}$ and $3.6 \text{ J}\cdot\text{cm}^{-2}$, respectively (for slightly shorter wavelengths and pulse lengths). Therefore, a value $F_{th} = 4 \text{ J}\cdot\text{cm}^{-2}$ was considered for the design of the experiment. Areas were scanned by lines of alternating directions with line spacing L_s and a constant scan velocity v_s , resulting in pulse separation s_s .

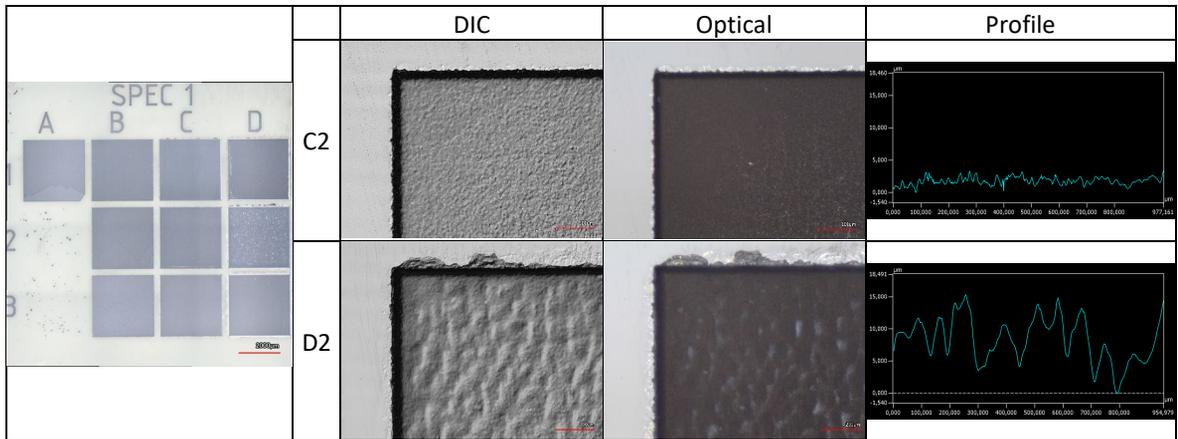
Fig. 2. Comparison of areas C2 and D2 on Spec 1, D2 shows typical defects – edge chipping, uneven surface, and traces of recast material (white areas on optical image). Profiles have same Z-axis size, scale 200 μm .

can be found in Fig 2 – D2 area). The red colour of values is used for indication of edge chipping. The orange colour of the cell show occurrence of areas ablated to a greater depth than surrounding areas (craters). Blue text colour is used for indication of highly periodic surface formation with period equal to L_s - 12.5 μm .

Some recast material, that was not removed by cleaning was observed on the edges of the “D” samples. Most of the defects were observed within areas where the lowest line spacing was used, especially combined with higher pulse energy and low scan speed. Areas with high spots-per-area number yielded the worst surface

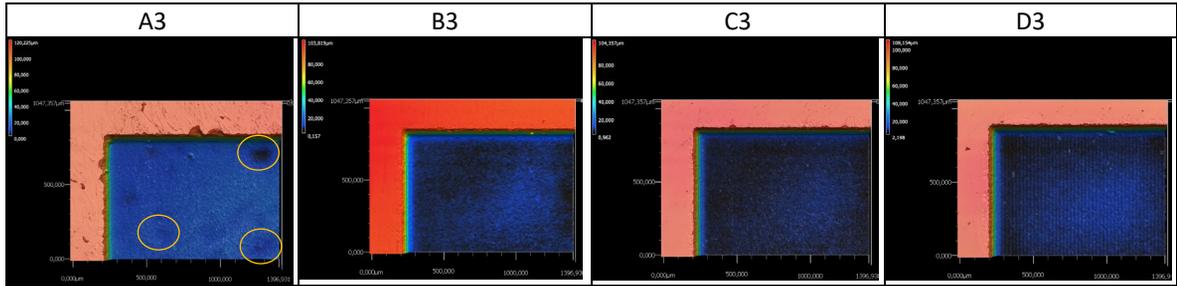
Fig. 3. Height images of areas on Spec 3, yellow ellipses on A3 show locations of craters. Visible linear periodic structures on D3 (note that “higher” – lighter blue areas on images are microscope related, as they are observed on most of the images).

Table 3 shows the results of roughness and depth measurement on Spec 3. Although the areas processed with low interlacing (column A) showed a similar roughness as those processed with the higher interlacing, severe creation of local craters of depth up to $10 \mu\text{m}$ was observed. Edge chipping also occurred on samples within this column. This is demonstrated in Fig. 3, where the resulting surfaces of areas from row 3 are shown. Ablated depths of areas without visible defects were measured to be very similar to each other (see Columns B, C in Table. 3). High-interlaced column D showed a slightly higher ablation depth in contrast to more closely hatched areas, but at the cost of high-roughness.

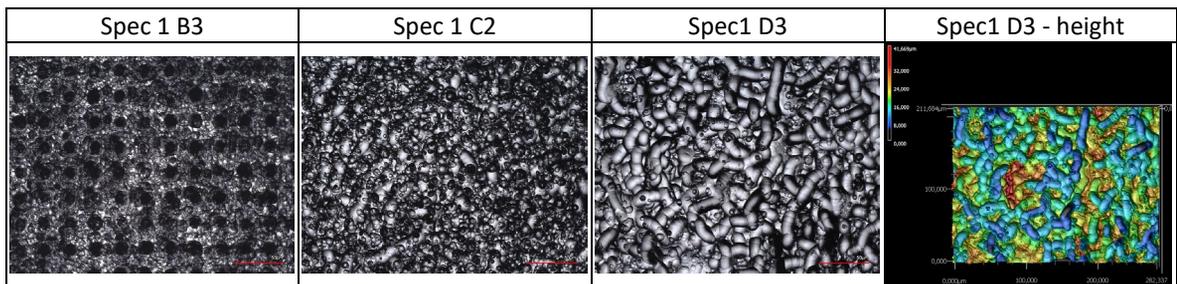
Fig. 4. Structures formed after etching on Spec 1 (scale $50 \mu\text{m}$).

The etching of the sample caused creation of a mostly chaotic structure. Samples in columns B and C showed similar behaviour – random, bubble-like structures (example on Fig. 4 – Spec 1 C2) with S_a exceeding $2 \mu\text{m}$ and S_z (maximal height) $15 \mu\text{m}$. In area B3, a highly regular periodic structure composed of circular holes of depth at least $10 \mu\text{m}$ (missing microscope data in central – deep – part), diameter $11 \mu\text{m}$ and spacing of $25 \mu\text{m}$ (double of the original periodicity of the sample surface). In column D surface is formed of the random channels of width and depth both approx. $13 \mu\text{m}$, which might originate in sub-surface cracks.

Samples in column B were etched to a depth of around $22 \mu\text{m}$, in column C to $24 \mu\text{m}$. Samples D2 and D3 were etched to a depth of $42 \mu\text{m}$ and $40 \mu\text{m}$ respectively. Although all areas were etched in the same process, the D1 area was measured to be $13 \mu\text{m}$ on average deeper than before etching. The original polished surfaces of the glass sample showed damage after etching – random dimples approx. $4 \mu\text{m}$ in diameter.
